31 Bridgend,
Dunblane,
FK15 9ES

Home Report

Single Survey

Property Address	31 Bridgend, Dunblane, FK15 9ES
Reference	1448354
Customer Name	Executry for the Late Kurt-Hans Goedicke Langan
Date of Inspection	25th February 2026
Surveyor's name, qualifications and office	Gordon McCulloch DipSurv. MRICS DM Hall LLP Chartered Surveyors Suite 2C 1 Pitt Terrace Stirling FK8 2EZ Tel: 01786 475785 email: stirlingresidential@dmhall.co.uk
Prepared By	DM Hall LLP

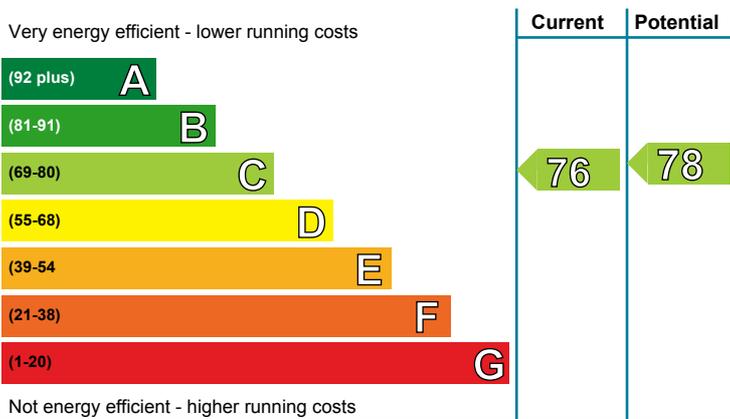
Energy Efficiency Rating

This graph shows the current efficiency of your home, taking into account both energy efficiency and fuel costs. The higher this rating, the lower your fuel bills are likely to be.

Your current rating is **band C (76)**. The average rating for EPCs in Scotland is **band D (61)**.

The potential rating shows the effect of undertaking all of the improvement measures listed within your recommendations report.

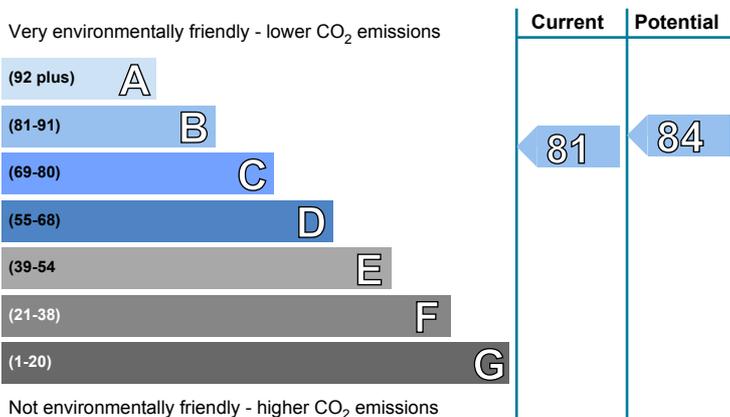
Environmental Impact (CO₂) Rating

This graph shows the effect of your home on the environment in terms of carbon dioxide (CO₂) emissions. The higher the rating, the less impact it has on the environment.
