# Home Report

44 Old Doune Road  
Dunblane FK15 9BU

# Single Survey

<b>Property Address</b>	44 Old Doune Road Dunblane FK15 9BU
<b>Customer</b>	Alexander Watt and Rebekah Easson
<b>Prepared by</b>	Graham + Sibbald Property Consultants Limited
<b>Date of Inspection</b>	01/06/2026

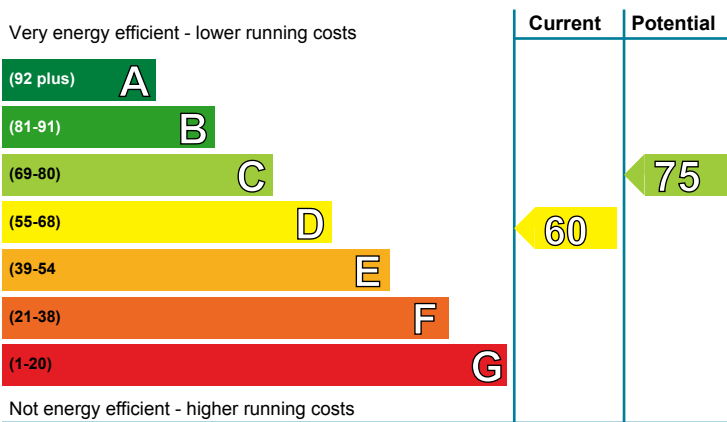
## Energy Efficiency Rating

This graph shows the current efficiency of your home, taking into account both energy efficiency and fuel costs. The higher this rating, the lower your fuel bills are likely to be.

Your current rating is **band D (60)**. The average rating for EPCs in Scotland is **band D (61)**.

The potential rating shows the effect of undertaking all of the improvement measures listed within your recommendations report.

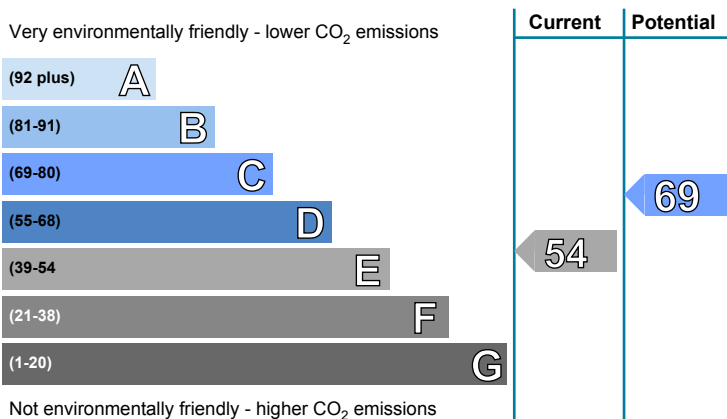
## Environmental Impact (CO<sub>2</sub>) Rating

This graph shows the effect of your home on the environment in terms of carbon dioxide (CO<sub>2</sub>) emissions. The higher the rating, the less impact it has on the environment.
