Single Survey

Property address	Eleanburn Bridge Of Gairn Ballater AB35 5UD
-------------------------	--

Prepared by	Shepherd Chartered Surveyors
--------------------	------------------------------

Date of inspection	04/07/2024
---------------------------	------------

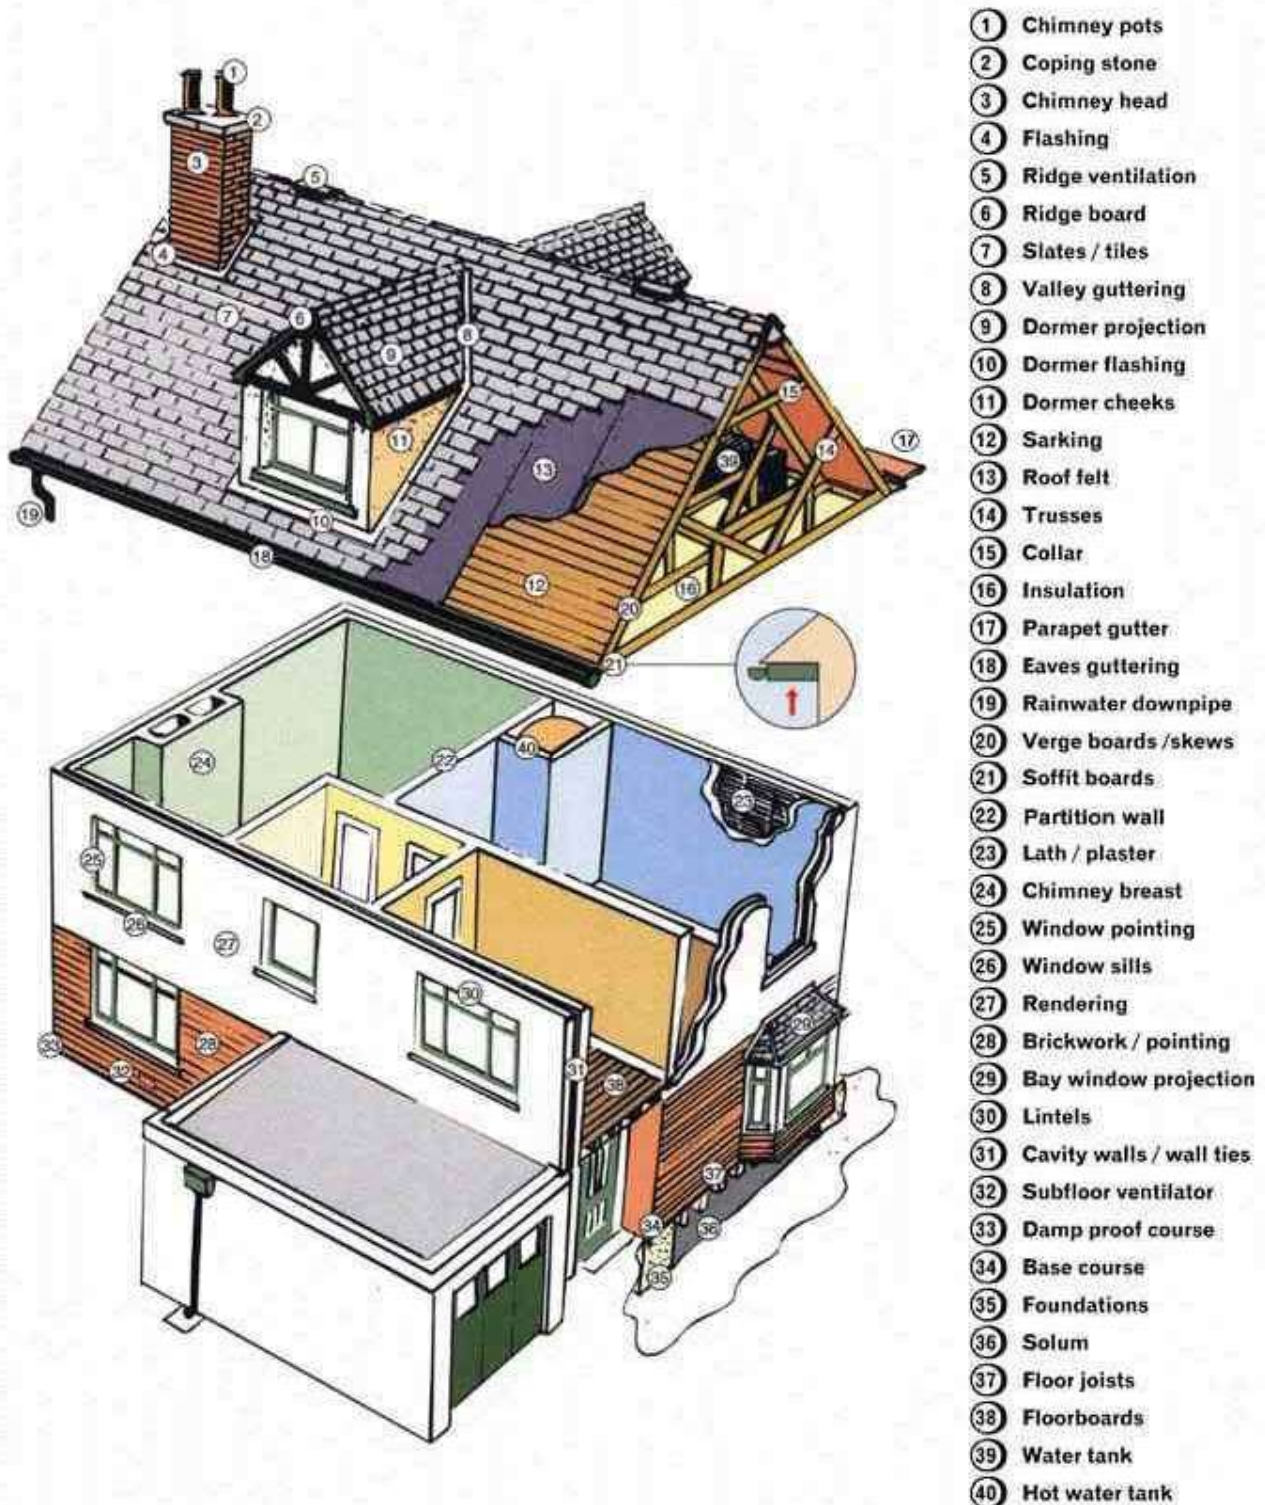
Sectional Diagram showing elements of a typical house

Reference may be made in this report to some or all of the above component parts of the property. This diagram may assist you in locating and understanding these items.
