# Home Report

# Scottish Single Survey

<b>Property address</b>	3 Stewart Walk Alford AB33 8TF
<b>Customer</b>	Mrs Donna Hobson
<b>Customer address</b>	3 Stewart Walk Alford AB33 8TF
<b>Prepared by</b>	Shepherd Chartered Surveyors
<b>Date of inspection</b>	30/04/2026

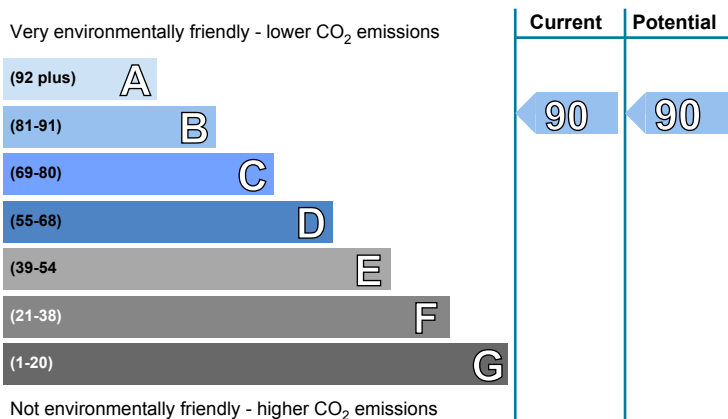
## Environmental Impact (CO<sub>2</sub>) Rating

This graph shows the effect of your home on the environment in terms of carbon dioxide (CO<sub>2</sub>) emissions. The higher the rating, the less impact it has on the environment.
