# Home Report

# Scottish Single Survey

<b>Property address</b>	36 Whinpark Circle Portlethen Aberdeen AB12 4SS
-------------------------	--

<b>Prepared by</b>	Shepherd Chartered Surveyors
--------------------	------------------------------

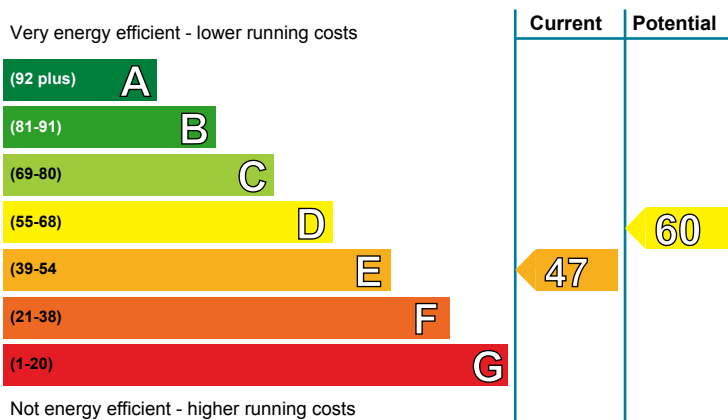
## Energy Efficiency Rating

This graph shows the current efficiency of your home, taking into account both energy efficiency and fuel costs. The higher this rating, the lower your fuel bills are likely to be.

Your current rating is **band E (47)**. The average rating for EPCs in Scotland is **band D (61)**.

The potential rating shows the effect of undertaking all of the improvement measures listed within your recommendations report.
