# Single Survey

<b>Property address</b>	Cairnside, Monymusk, Inverurie, AB51 7HX
-------------------------	---

<b>Prepared by</b>	Allied Surveyors Scotland Ltd
--------------------	-------------------------------

<b>Date of inspection</b>	27th November 2025
---------------------------	--------------------

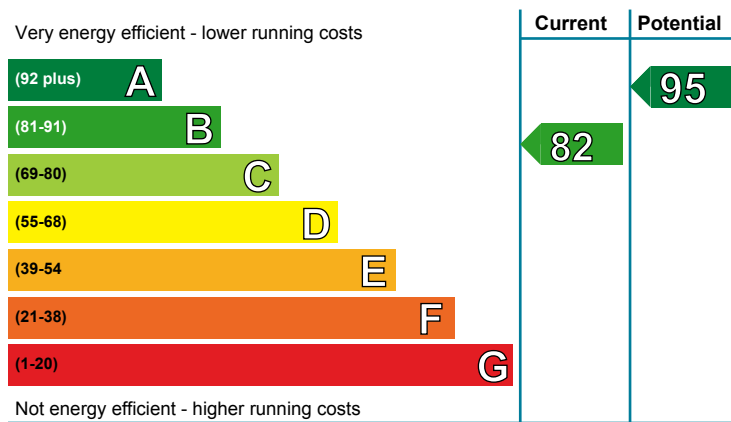
## Energy Efficiency Rating

This graph shows the current efficiency of your home, taking into account both energy efficiency and fuel costs. The higher this rating, the lower your fuel bills are likely to be.

Your current rating is **band B (82)**. The average rating for EPCs in Scotland is **band D (61)**.

The potential rating shows the effect of undertaking all of the improvement measures listed within your recommendations report.

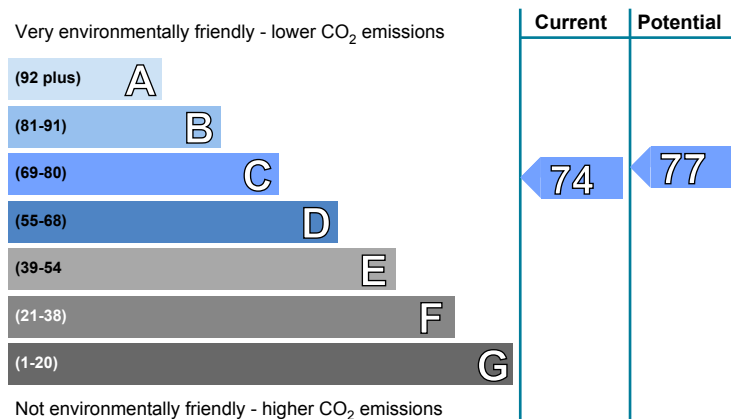
## Environmental Impact (CO<sub>2</sub>) Rating

This graph shows the effect of your home on the environment in terms of carbon dioxide (CO<sub>2</sub>) emissions. The higher the rating, the less impact it has on the environment.
