Single Survey

Property address	Mill Of Echt, Echt, Westhill, AB32 7AD
-------------------------	---

Prepared by	Harvey Donaldson And Gibson
--------------------	-----------------------------

Date of inspection	19th September 2023
---------------------------	---------------------

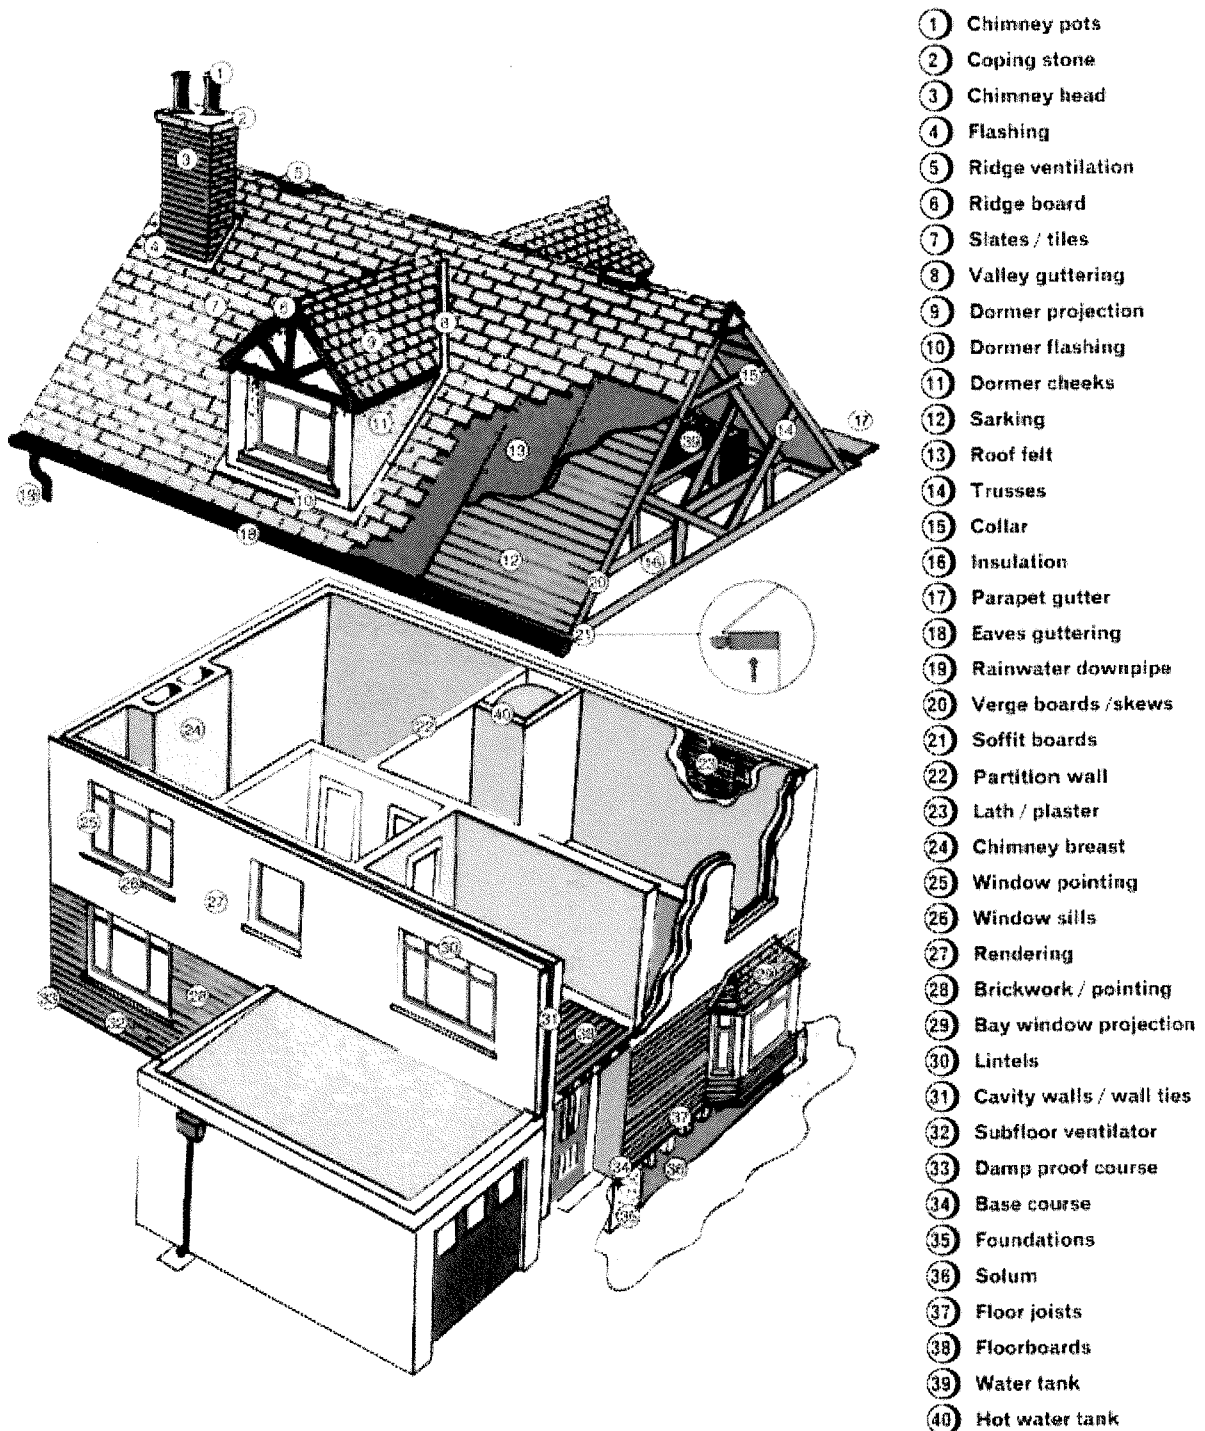
Sectional Diagram showing elements of a typical house

- ① Chimney pots
- ② Coping stone
- ③ Chimney head
- ④ Flashing
- ⑤ Ridge ventilation
- ⑥ Ridge board
- ⑦ Slates / tiles
- ⑧ Valley guttering
- ⑨ Dormer projection
- ⑩ Dormer flashing
- ⑪ Dormer cheeks
- ⑫ Sarking
- ⑬ Roof felt
- ⑭ Trusses
- ⑮ Collar
- ⑯ Insulation
- ⑰ Parapet gutter
- ⑱ Eaves guttering
- ⑲ Rainwater downpipe
- ⑳ Verge boards /skews
- ㉑ Soffit boards
- ㉒ Partition wall
- ㉓ Lath / plaster
- ㉔ Chimney breast
- ㉕ Window pointing
- ㉖ Window sills
- ㉗ Rendering
- ㉘ Brickwork / pointing
- ㉙ Bay window projection
- ㉚ Lintels
- ㉛ Cavity walls / wall ties
- ㉜ Subfloor ventilator
- ㉝ Damp proof course
- ㉞ Base course
- ㉟ Foundations
- ㊱ Solum
- ㊲ Floor joists
- ㊳ Floorboards
- ㊴ Water tank
- ㊵ Hot water tank

Reference may be made in this report to some or all of the above component parts of the property. This diagram may assist you in locating and understanding these items.
