Home Report

Single Survey

Property address	Ryehill 14 Greystone Road Alford AB33 8TY
Customer	Mr & Mrs T Joyce
Customer address	Ryehill 14 Greystone Road Alford AB33 8TY
Prepared by	Shepherd Chartered Surveyors
Date of inspection	02/09/2025

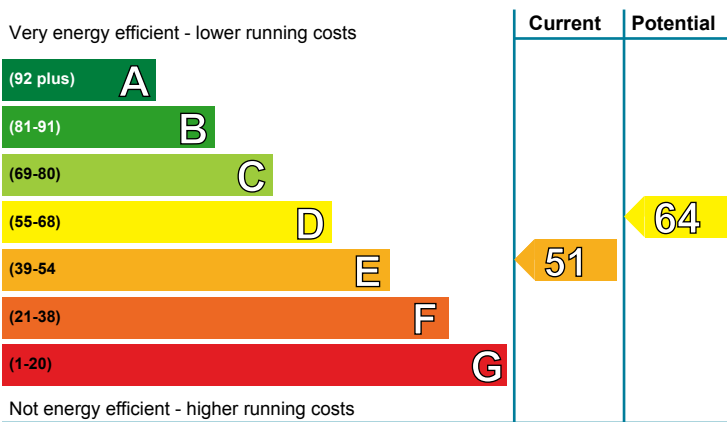
Energy Efficiency Rating

This graph shows the current efficiency of your home, taking into account both energy efficiency and fuel costs. The higher this rating, the lower your fuel bills are likely to be.

Your current rating is **band E (51)**. The average rating for EPCs in Scotland is **band D (61)**.

The potential rating shows the effect of undertaking all of the improvement measures listed within your recommendations report.
