HOME REPORT

26 CALEDONIAN COURT
EASTWELL ROAD
DUNDEE
DD2 3FF

Energy Performance Certificate (EPC)

26 CALEDONIAN COURT, EASTWELL ROAD, DUNDEE, DD2 3FF

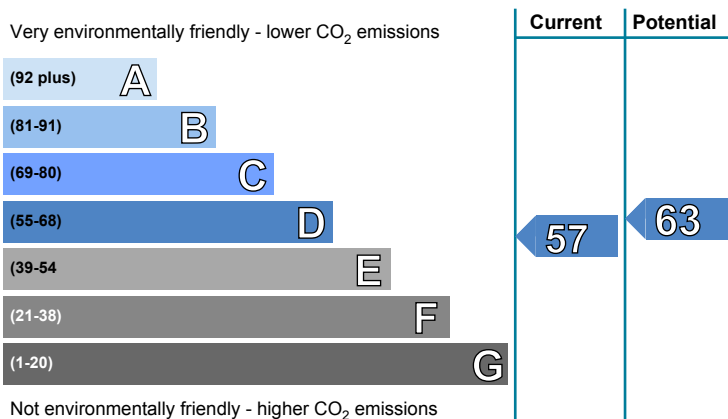
Environmental Impact (CO₂) Rating

This graph shows the effect of your home on the environment in terms of carbon dioxide (CO₂) emissions. The higher the rating, the less impact it has on the environment.

Your current rating is **band D (57)**. The average rating for EPCs in Scotland is **band D (59)**.

The potential rating shows the effect of undertaking all of the improvement measures listed within your recommendations report.
