Home Report

Woodfield House Swineabbey
East Whitburn EH47 7RH

Date of Valuation: 08/07/2024

single survey

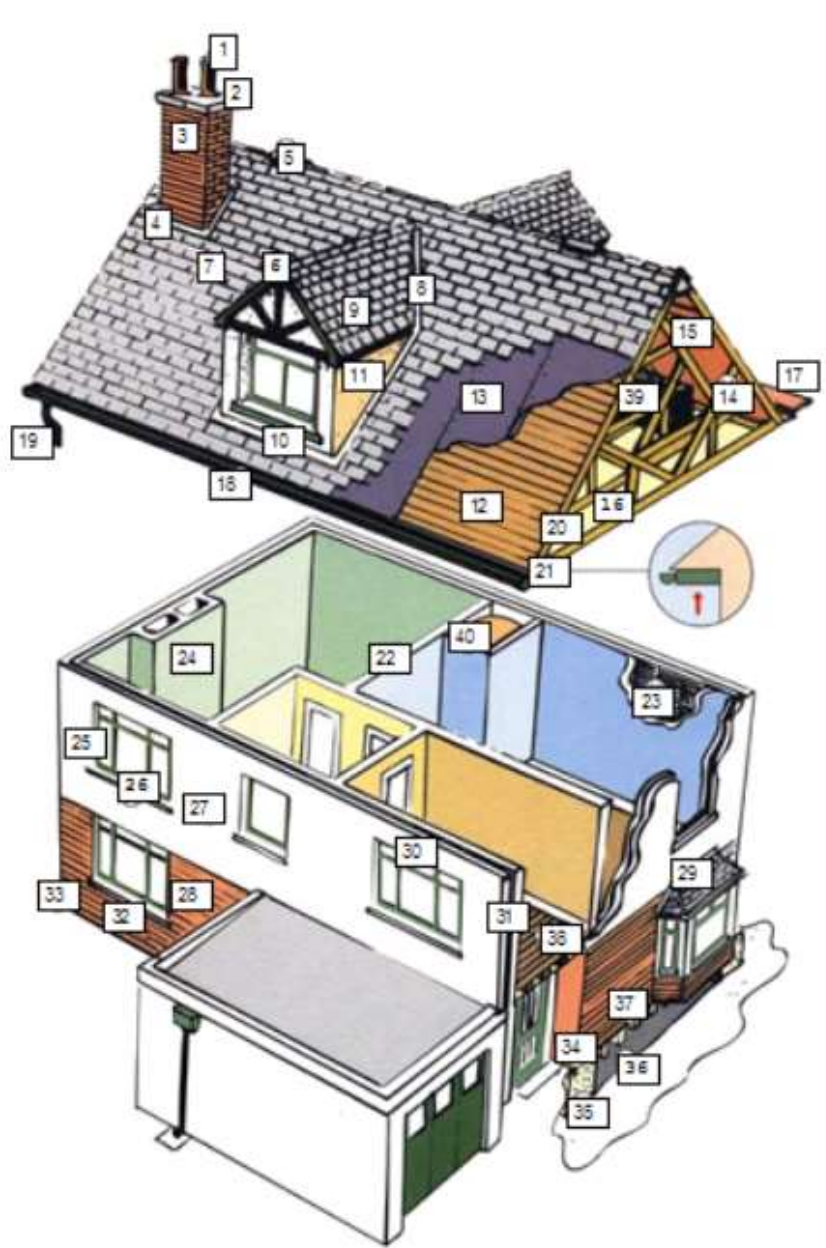
Sectional Diagram showing elements of a typical house

1	Chimney pots
2	Coping stone
3	Chimney head
4	Flashing
5	Ridge ventilation
6	Ridge board
7	Slates/tiles
8	Valley guttering
9	Dormer projection
10	Dormer flashing
11	Dormer cheeks
12	Sarking
13	Roof felt
14	Trusses
15	Collar
16	Insulation
17	Parapet gutter
18	Eaves guttering
19	Rainwater downpipe
20	Verge boards / skews
21	Soffit boards
22	Partition wall
23	Lath / plaster
24	Chimney breast
25	Window pointing
26	Window sills
27	Rendering
28	Brickwork / pointing
29	Bay window projection
30	Lintels
31	Cavity walls / wall ties
32	Subfloor ventilator
33	Damp proof course
34	Base course
35	Foundations
36	Solum
37	Floor joists
38	Floorboards
39	Water tank
40	Hot water tank

Reference may be made in this report to some or all of the above component parts of the property. This diagram may assist you in locating and understanding these items.

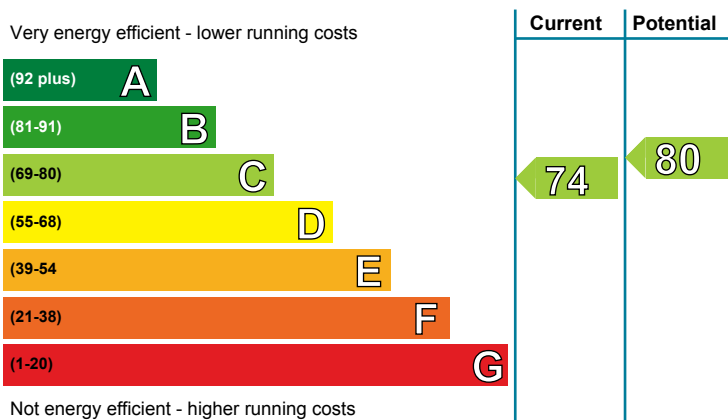
Energy Efficiency Rating

This graph shows the current efficiency of your home, taking into account both energy efficiency and fuel costs. The higher this rating, the lower your fuel bills are likely to be.

Your current rating is **band C (74)**. The average rating for EPCs in Scotland is **band D (61)**.

The potential rating shows the effect of undertaking all of the improvement measures listed within your recommendations report.

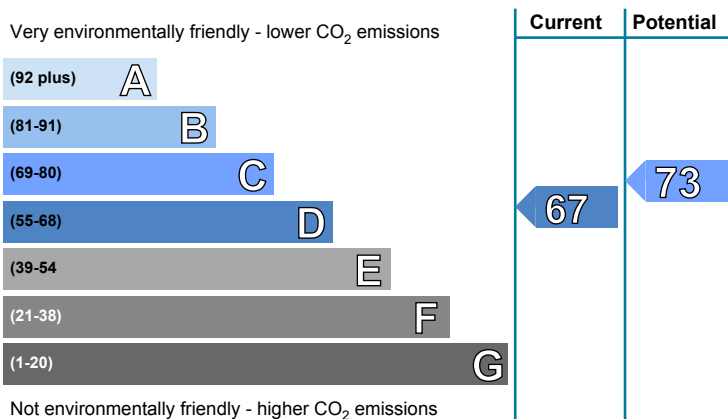
Environmental Impact (CO₂) Rating

This graph shows the effect of your home on the environment in terms of carbon dioxide (CO₂) emissions. The higher the rating, the less impact it has on the environment.
