# Home Report

# Scottish Single Survey

# Single Survey

| Property address | 4 Skipness Avenue<br>Carluke<br>ML8 4LT |

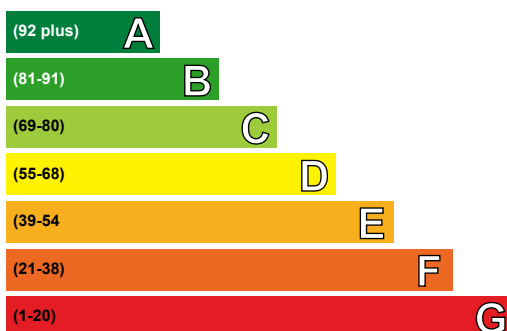
\* based upon the cost of energy for heating, hot water, lighting and ventilation, calculated using standard assumptions

Very energy efficient - lower running costs

Not energy efficient - higher running costs

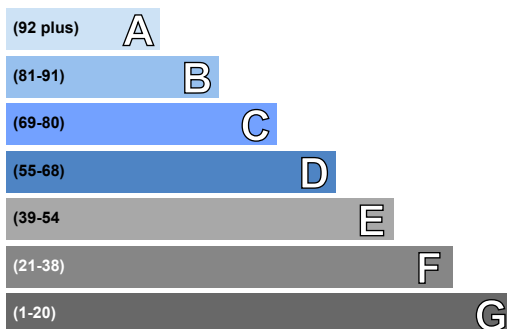
Very environmentally friendly - lower CO<sub>2</sub> emissions

Not environmentally friendly - higher CO<sub>2</sub> emissions
