ARD NA GREINE  
CRAIGSTON  
TURRIFF  
AB53 5PX

# HOME REPORT

Ard na Greine

# SINGLE SURVEY

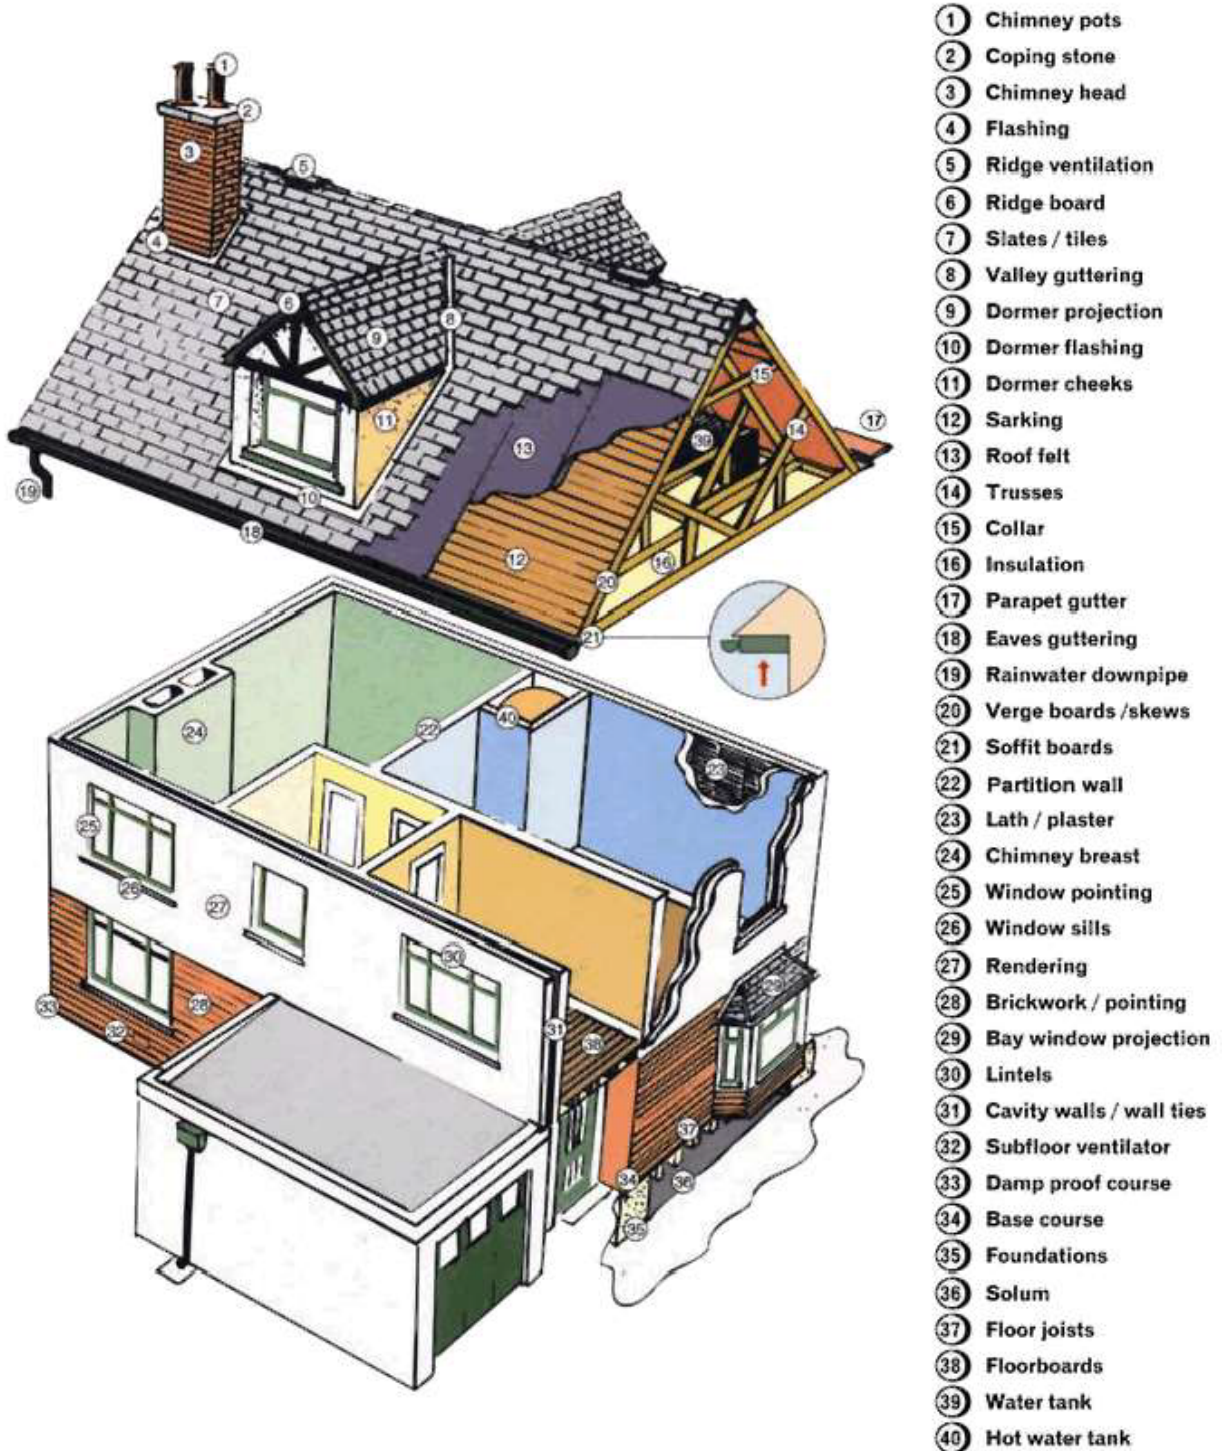
## Sectional Diagram showing elements of a typical house

Reference may be made in this report to some or all of the above component parts of the property. This diagram may assist you in locating and understanding these items.

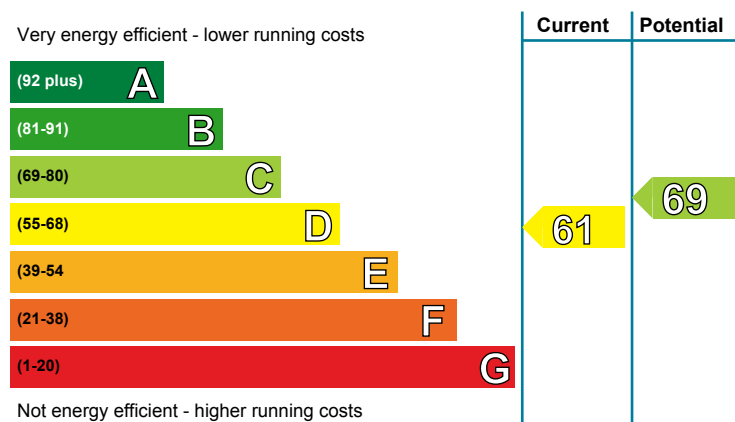
## Energy Efficiency Rating

This graph shows the current efficiency of your home, taking into account both energy efficiency and fuel costs. The higher this rating, the lower your fuel bills are likely to be.

Your current rating is **band D (61)**. The average rating for EPCs in Scotland is **band D (61)**.

The potential rating shows the effect of undertaking all of the improvement measures listed within your recommendations report.

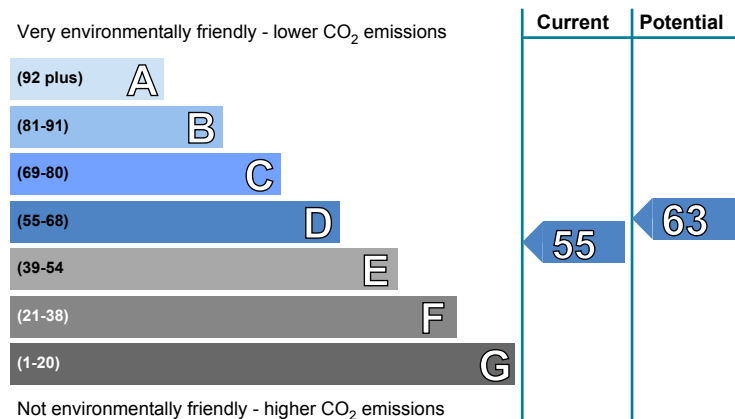
## Environmental Impact (CO<sub>2</sub>) Rating

This graph shows the effect of your home on the environment in terms of carbon dioxide (CO<sub>2</sub>) emissions. The higher the rating, the less impact it has on the environment.
