Home Report

Scottish Single Survey

Property address	16 Fa'side Road Tranent EH33 2BP
-------------------------	--

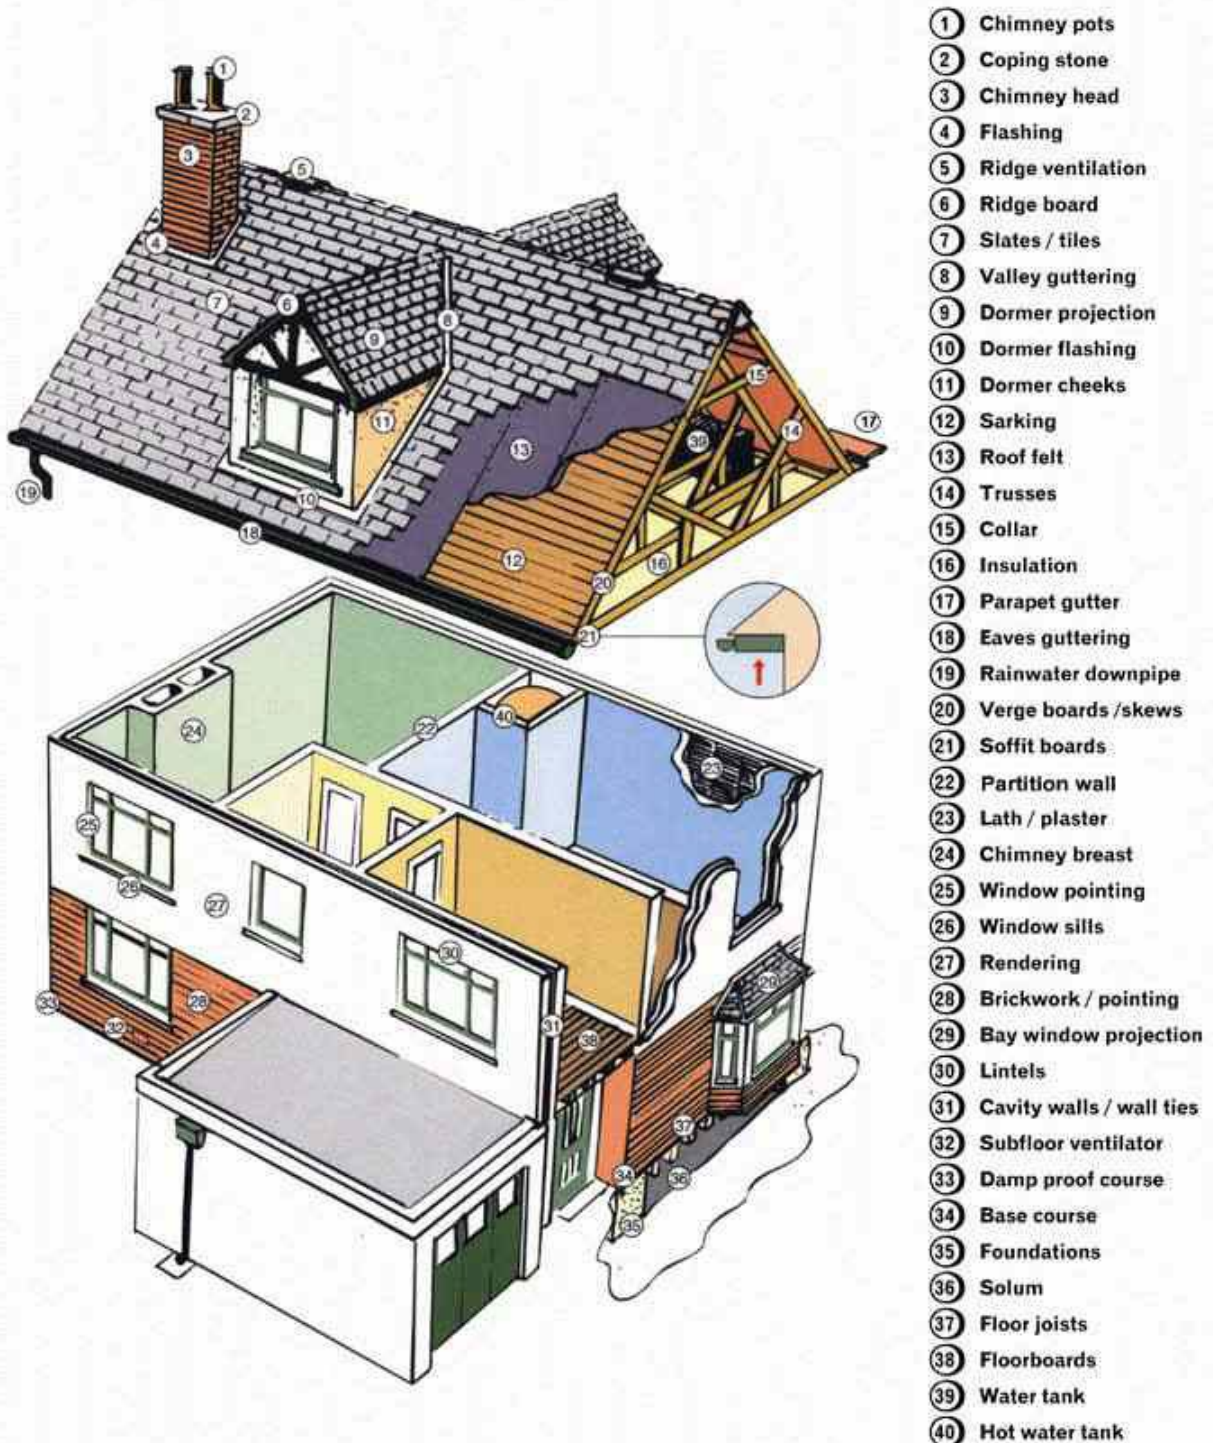
Sectional Diagram showing elements of a typical house

Reference may be made in this report to some or all of the above component parts of the property. This diagram may assist you in locating and understanding these items.
