Home Report

BRINDAVAN

ARDGAY
IV24 3DJ

Walker Fraser Steele
Chartered Surveyors

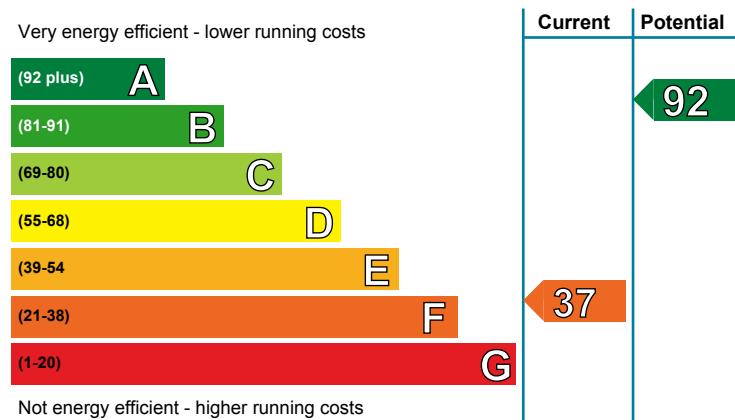
Energy Efficiency Rating

This graph shows the current efficiency of your home, taking into account both energy efficiency and fuel costs. The higher this rating, the lower your fuel bills are likely to be.

Your current rating is **band F (37)**. The average rating for EPCs in Scotland is **band D (61)**.

The potential rating shows the effect of undertaking all of the improvement measures listed within your recommendations report.

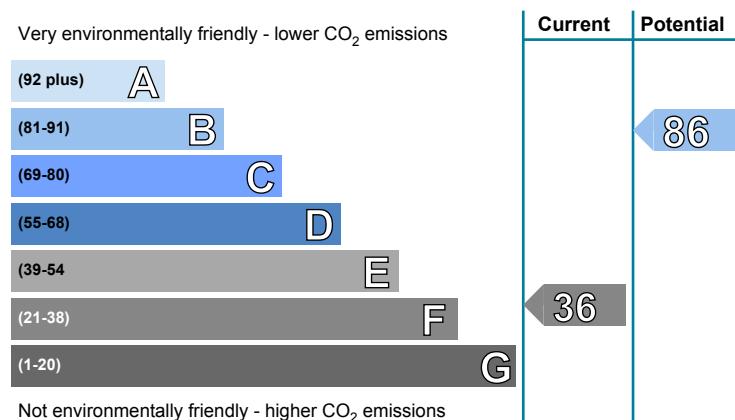
Environmental Impact (CO₂) Rating

This graph shows the effect of your home on the environment in terms of carbon dioxide (CO₂) emissions. The higher the rating, the less impact it has on the environment.

Your current rating is **band F (36)**. The average rating for EPCs in Scotland is **band D (59)**.

The potential rating shows the effect of undertaking all of the improvement measures listed within your recommendations report.

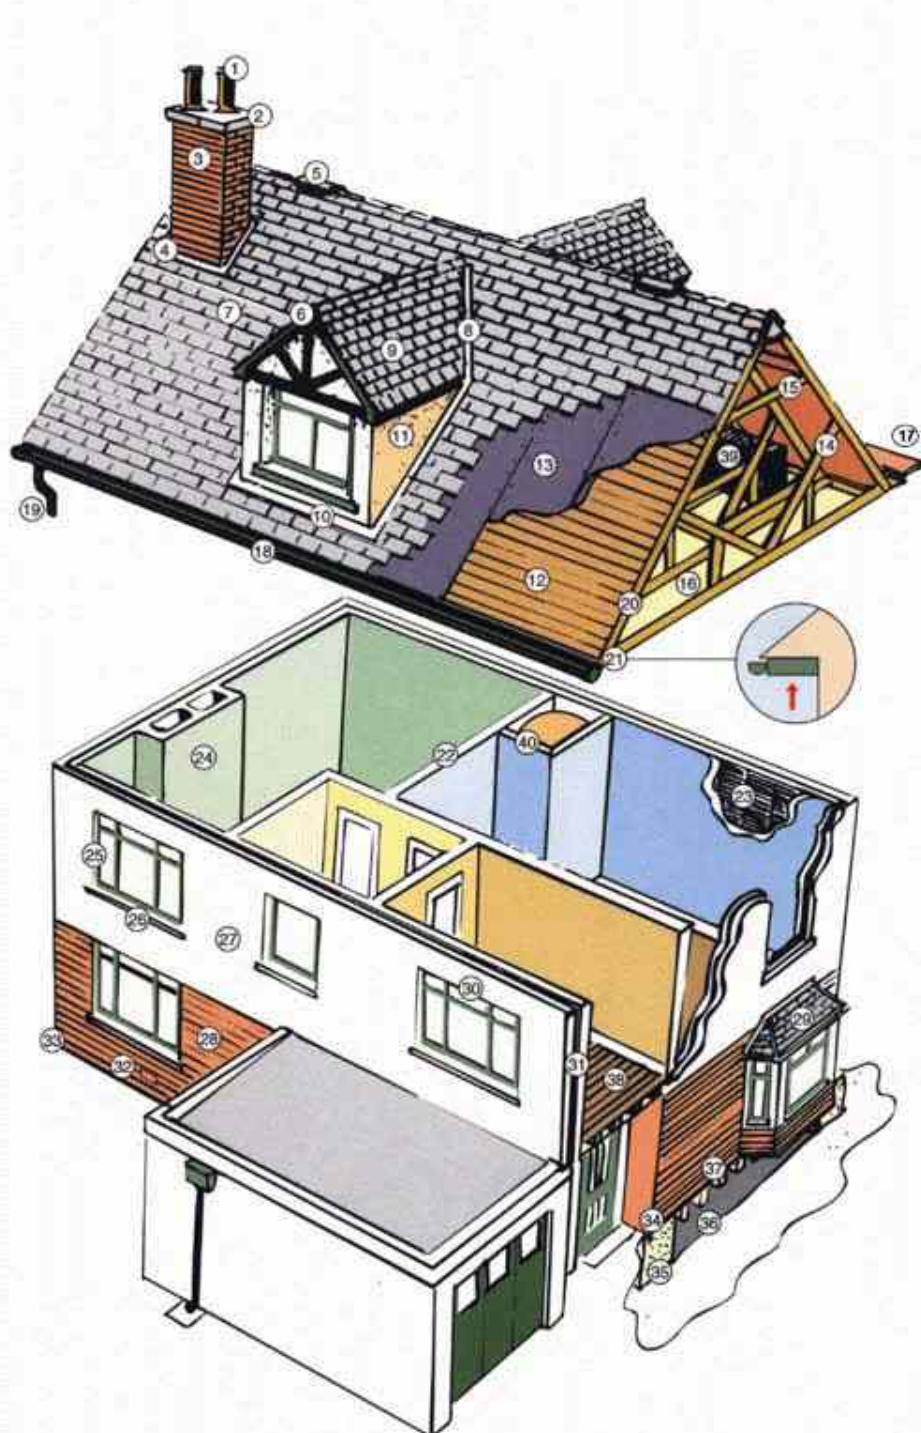
Sectional Diagram showing elements of a typical house

- 1 Chimney pots
- 2 Coping stone
- 3 Chimney head
- 4 Flashing
- 5 Ridge ventilation
- 6 Ridge board
- 7 Slates / tiles
- 8 Valley guttering
- 9 Dormer projection
- 10 Dormer flashing
- 11 Dormer cheeks
- 12 Sarking
- 13 Roof felt
- 14 Trusses
- 15 Collar
- 16 Insulation
- 17 Parapet gutter
- 18 Eaves guttering
- 19 Rainwater downpipe
- 20 Verge boards /skews
- 21 Soffit boards
- 22 Partition wall
- 23 Lath / plaster
- 24 Chimney breast
- 25 Window pointing
- 26 Window sills
- 27 Rendering
- 28 Brickwork / pointing
- 29 Bay window projection
- 30 Lintels
- 31 Cavity walls / wall ties
- 32 Subfloor ventilator
- 33 Damp proof course
- 34 Base course
- 35 Foundations
- 36 Solum
- 37 Floor joists
- 38 Floorboards
- 39 Water tank
- 40 Hot water tank

Reference may be made in this report to some or all of the above component parts of the property. This diagram may assist you in locating and understanding these items.
