# Home Report

CRAIGMHOR MAIN STREET

GOLSPIE  
KW10 6RA

# Energy Performance Certificate

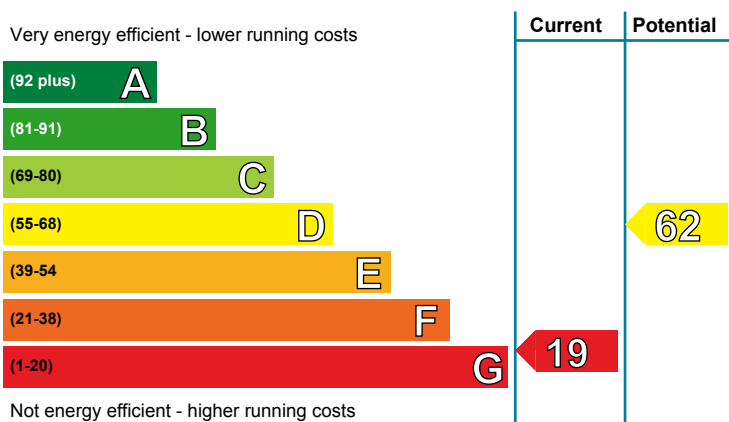
## Energy Efficiency Rating

This graph shows the current efficiency of your home, taking into account both energy efficiency and fuel costs. The higher this rating, the lower your fuel bills are likely to be.

Your current rating is **band G (19)**. The average rating for EPCs in Scotland is **band D (61)**.

The potential rating shows the effect of undertaking all of the improvement measures listed within your recommendations report.

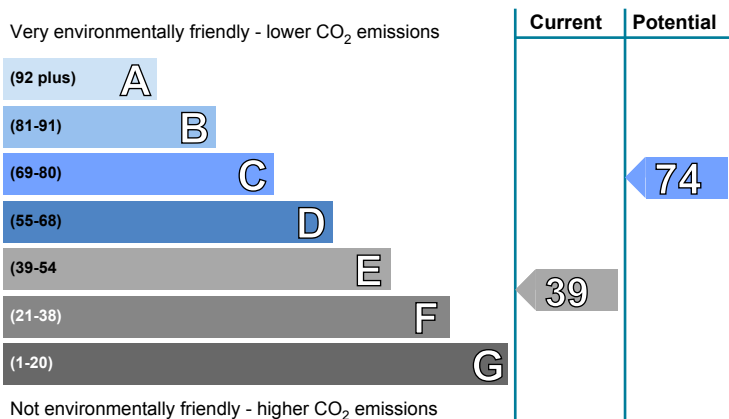
## Environmental Impact (CO<sub>2</sub>) Rating

This graph shows the effect of your home on the environment in terms of carbon dioxide (CO<sub>2</sub>) emissions. The higher the rating, the less impact it has on the environment.

Your current rating is **band E (39)**. The average rating for EPCs in Scotland is **band D (59)**.

The potential rating shows the effect of undertaking all of the improvement measures listed within your recommendations report.
