# Home Report

FOINAVEN ROSSAL

ROGART  
IV28 3UD

# Energy Performance Certificate (EPC)

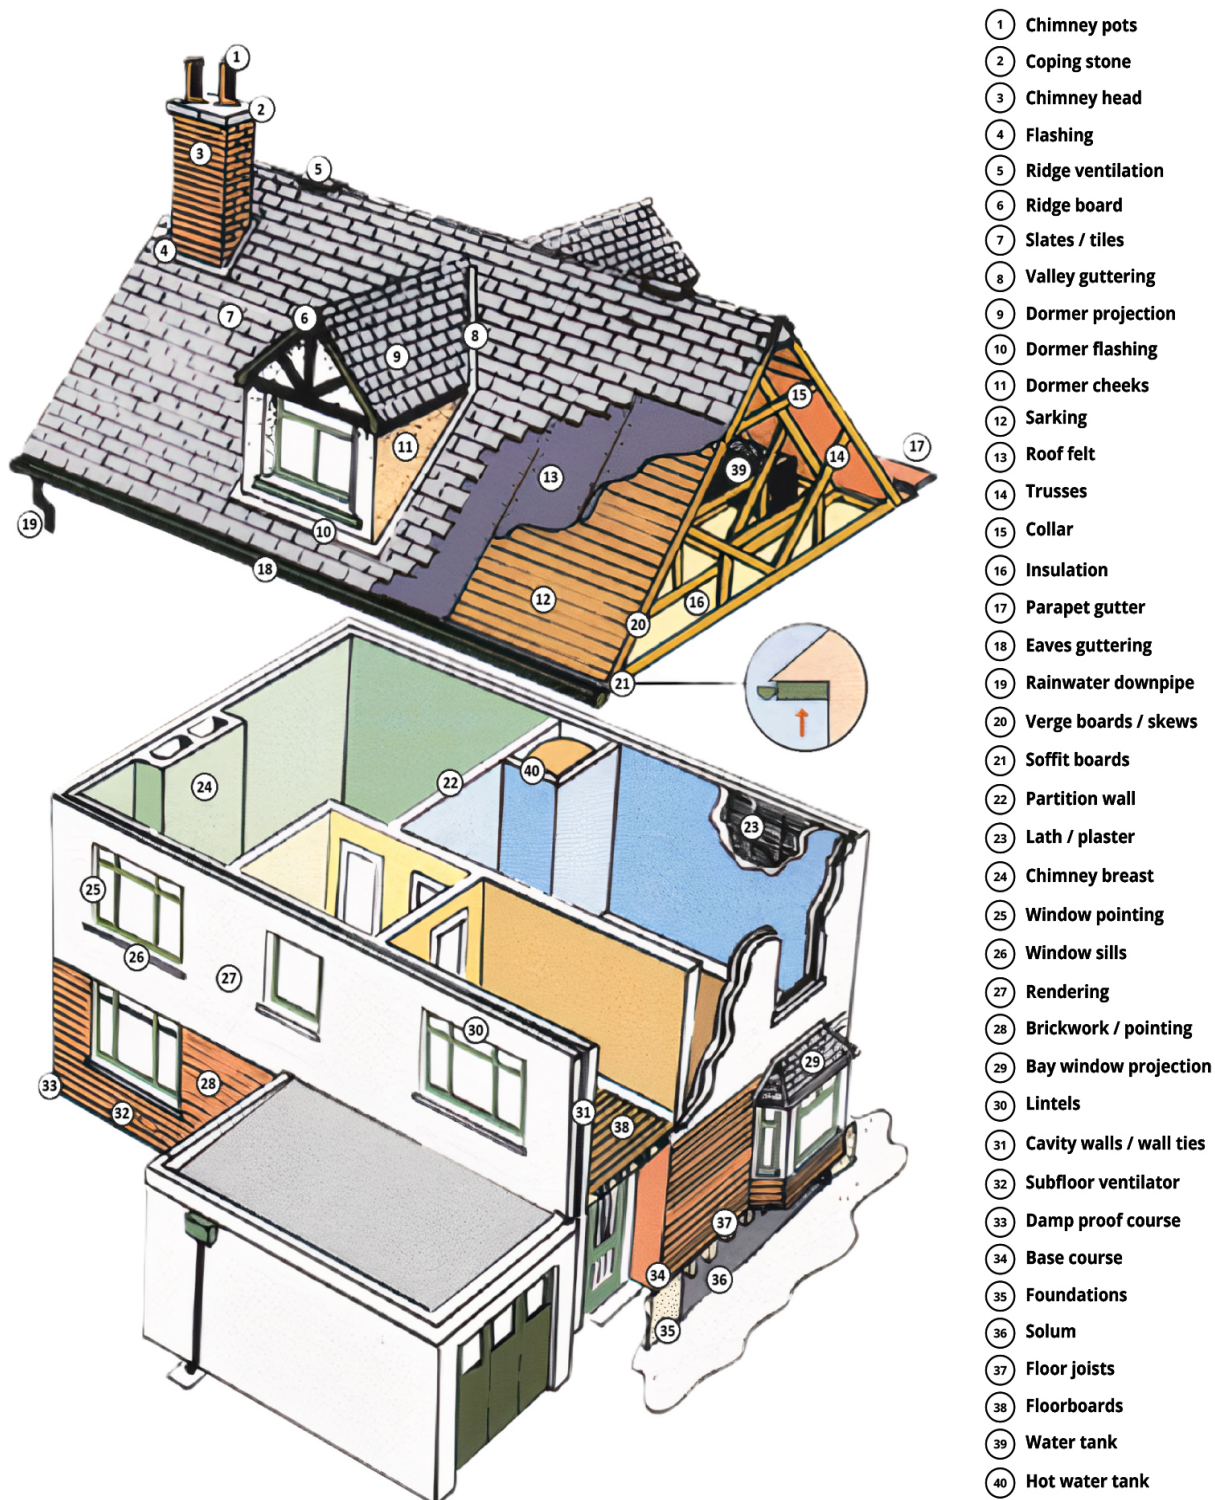
## Sectional Diagram showing elements of a typical house

Reference may be made in this report to some or all of the above component parts of the property. This diagram may assist you in locating and understanding these items.
