# Home Report

THE SCHOOLHOUSE ANKERVILLE  
STREET

TAIN  
IV19 1BL

Walker Fraser Steele  
Chartered Surveyors

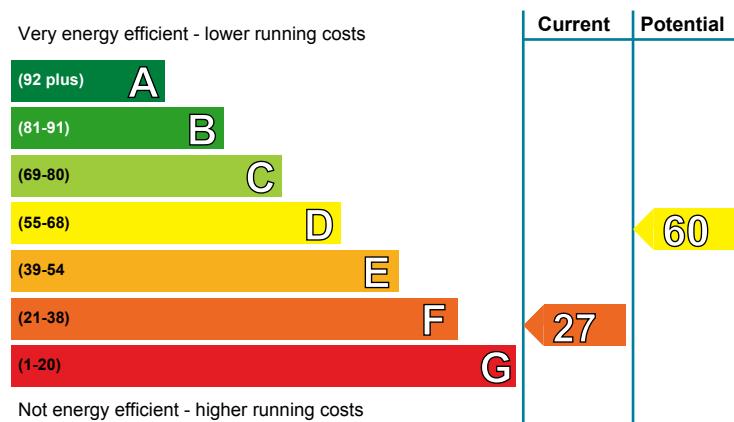
## Energy Efficiency Rating

This graph shows the current efficiency of your home, taking into account both energy efficiency and fuel costs. The higher this rating, the lower your fuel bills are likely to be.

Your current rating is **band F (27)**. The average rating for EPCs in Scotland is **band D (61)**.

The potential rating shows the effect of undertaking all of the improvement measures listed within your recommendations report.

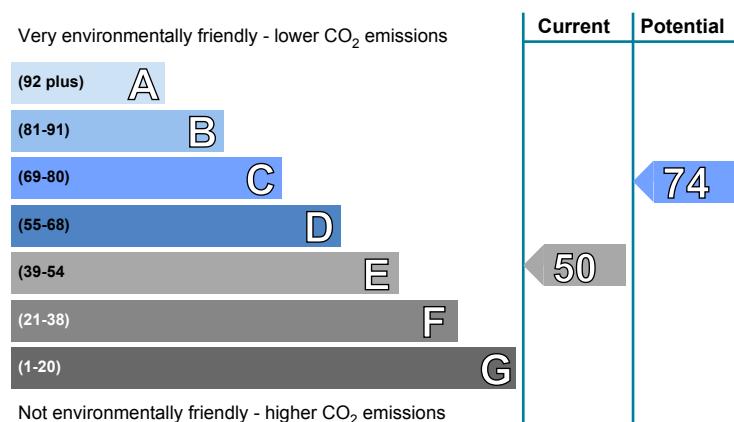
## Environmental Impact (CO<sub>2</sub>) Rating

This graph shows the effect of your home on the environment in terms of carbon dioxide (CO<sub>2</sub>) emissions. The higher the rating, the less impact it has on the environment.

Your current rating is **band E (50)**

The potential rating shows the effect of undertaking all of the improvement measures listed within your recommendations report.

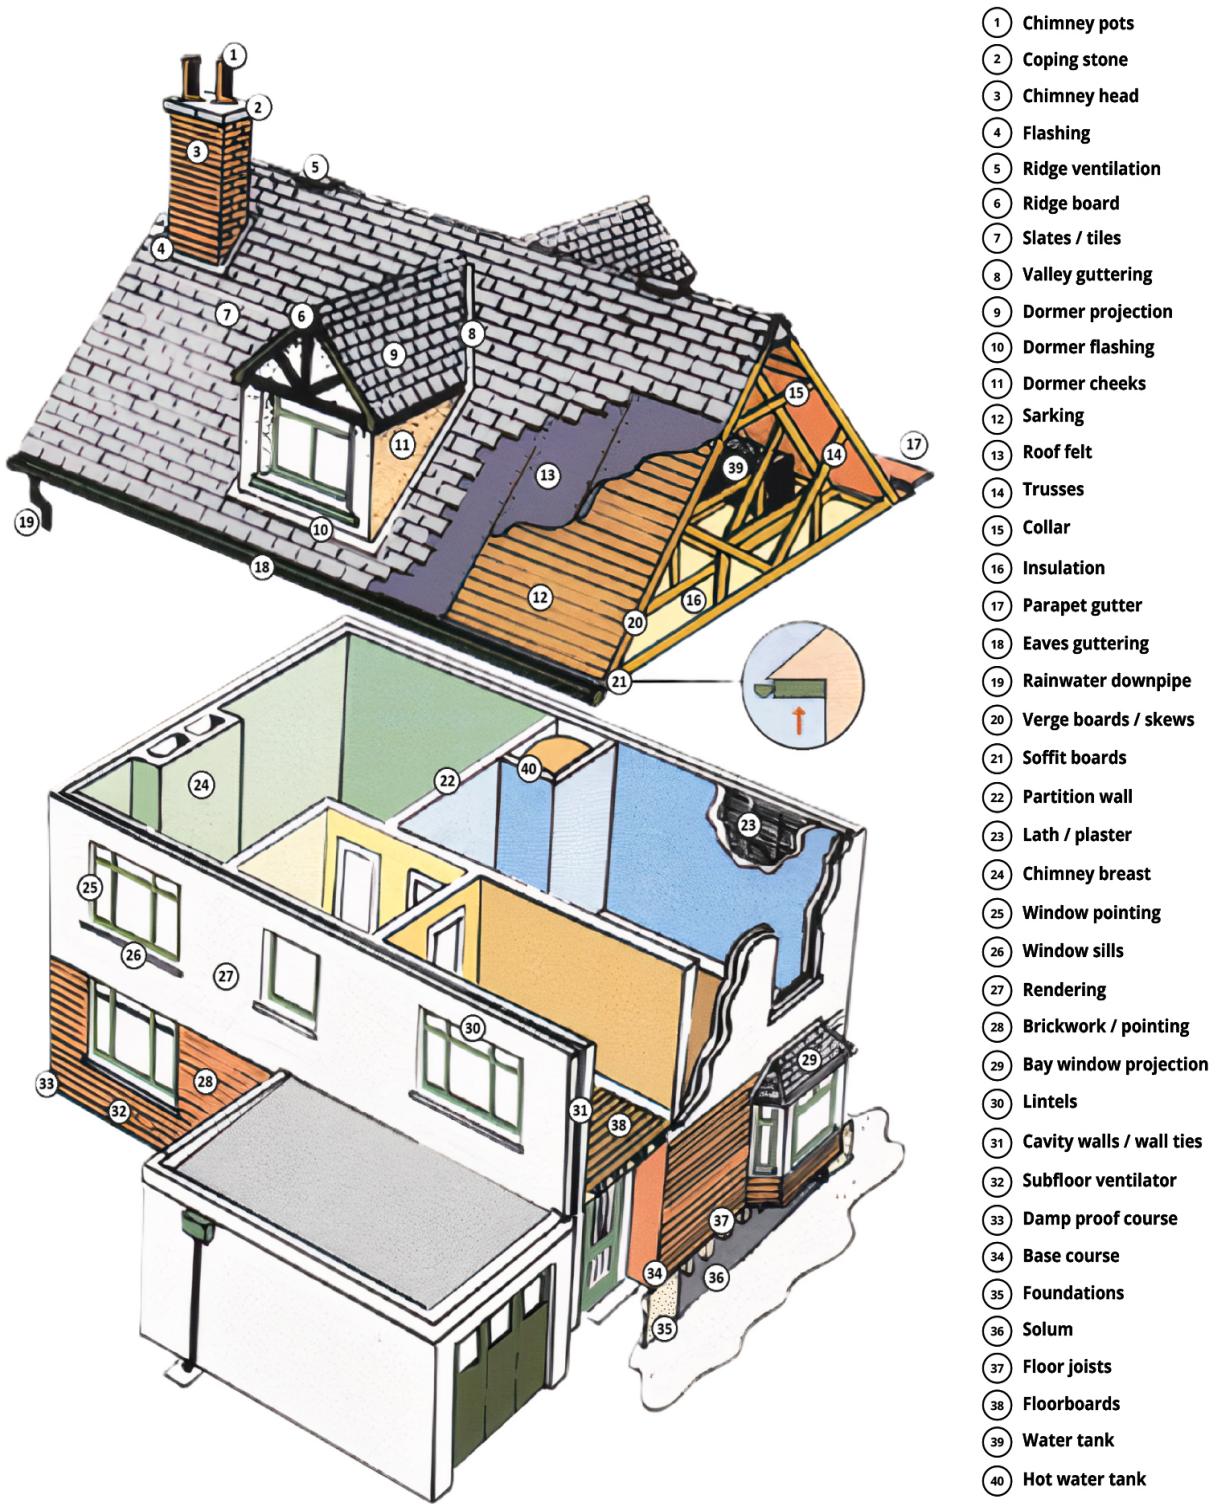
## Sectional Diagram showing elements of a typical house

Reference may be made in this report to some or all of the above component parts of the property. This diagram may assist you in locating and understanding these items.
