20 Darroch Brae,
Ainess,
Ross-Shire,
IV17 0SD

Home Report

Survey Report on:

Property Address	20 Darroch Brae, Alness, Ross-Shire, IV17 0SD
Reference	1318409
Customer Name	Alasdair Fraser
Date of Inspection	17th November 2025
Surveyor's name, qualifications and office	Simone Coles DM Hall LLP Chartered Surveyors Hope House, Cradlehall Business Park, Castlehill Drive Cradlehall Inverness IV2 5GH Tel: 01463 241077 email: invernessresidential@dmhall.co.uk
Prepared By	DM Hall LLP

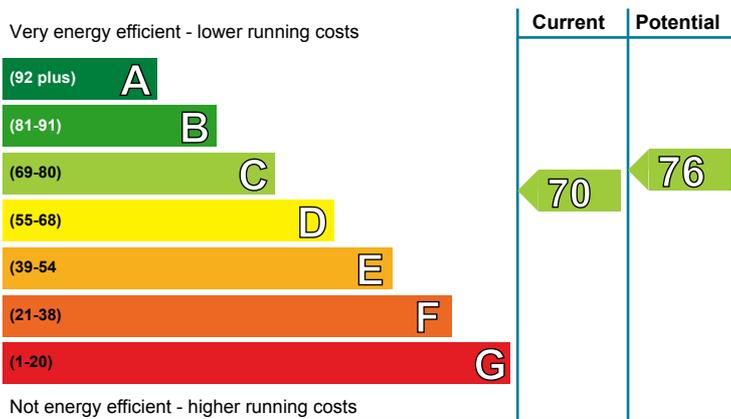
Energy Efficiency Rating

This graph shows the current efficiency of your home, taking into account both energy efficiency and fuel costs. The higher this rating, the lower your fuel bills are likely to be.

Your current rating is **band C (70)**. The average rating for EPCs in Scotland is **band D (61)**.

The potential rating shows the effect of undertaking all of the improvement measures listed within your recommendations report.

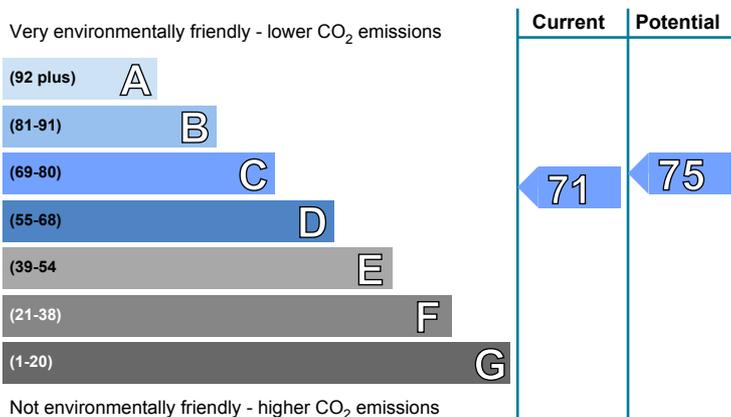
Environmental Impact (CO₂) Rating

This graph shows the effect of your home on the environment in terms of carbon dioxide (CO₂) emissions. The higher the rating, the less impact it has on the environment.
