Home Report

84 East Helmsdale
Strath Road
Helmsdale
KW8 6JL

**Walker Fraser Steele
Chartered Surveyors**

Property Address	84 East Helmsdale Strath Road Helmsdale KW8 6JL
Customer	Ms N Nussey
Date of Inspection	16/12/2025
Prepared by	Jennifer Swanson Walker Fraser Steele

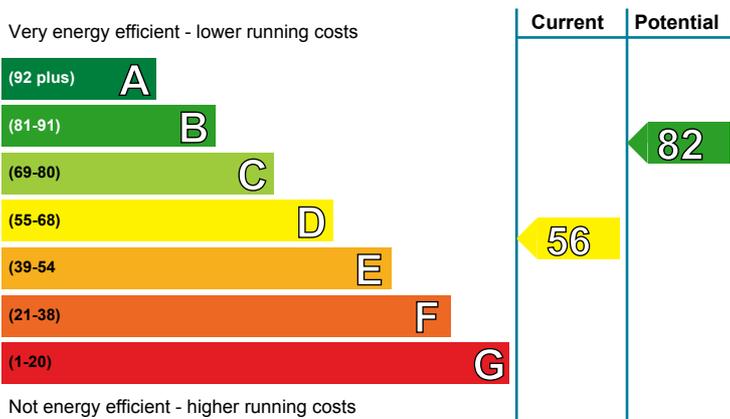
Energy Efficiency Rating

This graph shows the current efficiency of your home, taking into account both energy efficiency and fuel costs. The higher this rating, the lower your fuel bills are likely to be.

Your current rating is **band D (56)**. The average rating for EPCs in Scotland is **band D (61)**.

The potential rating shows the effect of undertaking all of the improvement measures listed within your recommendations report.

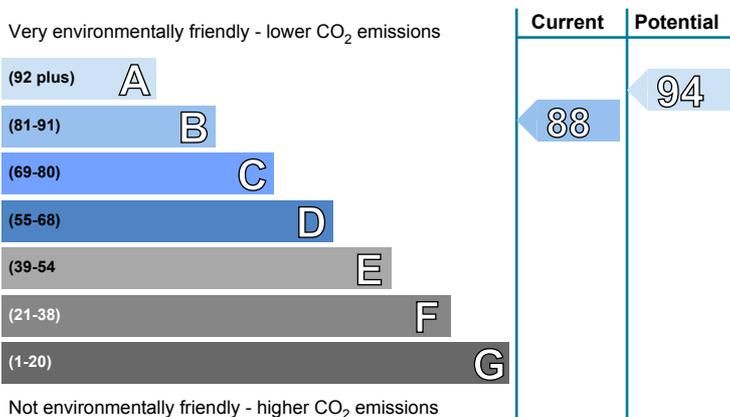
Environmental Impact (CO₂) Rating

This graph shows the effect of your home on the environment in terms of carbon dioxide (CO₂) emissions. The higher the rating, the less impact it has on the environment.

Your current rating is **band B (88)**

The potential rating shows the effect of undertaking all of the improvement measures listed within your recommendations report.

The average Scottish household produces about 6 tonnes of carbon dioxide every year. Based on this assessment, heating and lighting this home currently produces approximately 1.6 tonnes of carbon dioxide every year. Adopting recommendations in this report can reduce emissions and protect the environment. If you were to install all of these recommendations this could reduce emissions by 0.7 tonnes per year. You could reduce emissions even more by switching to renewable energy sources.

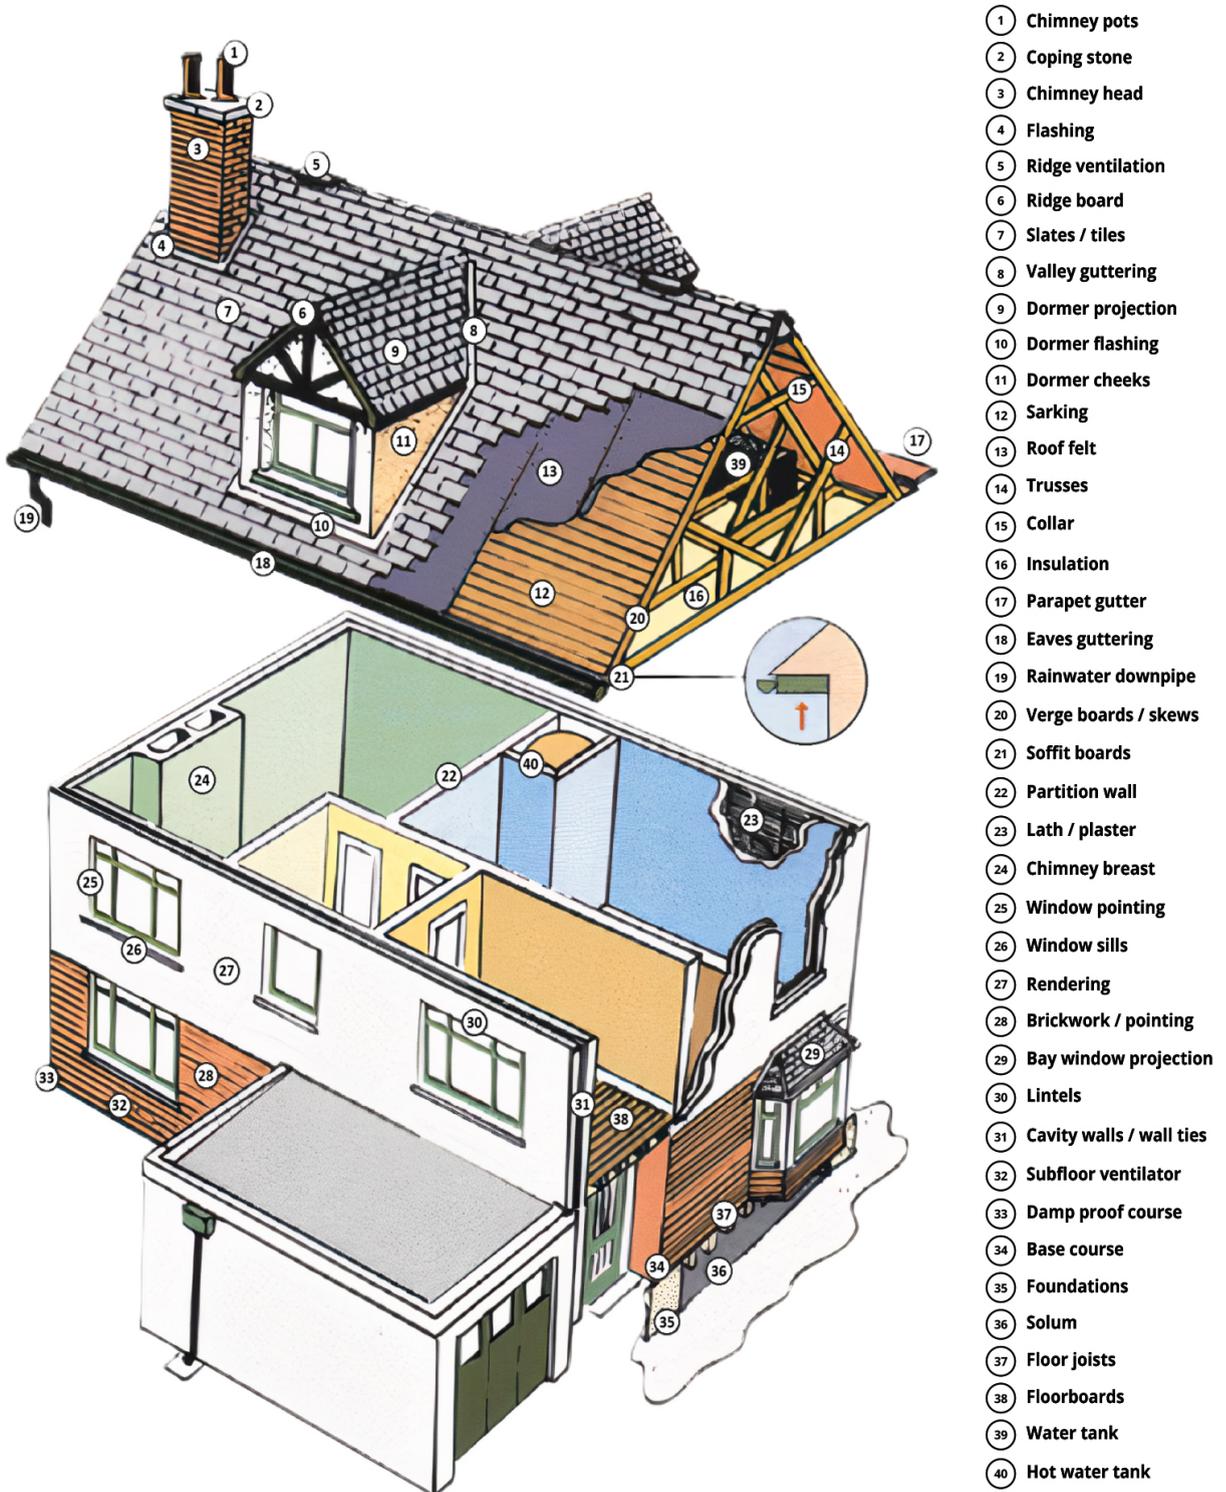
Sectional Diagram showing elements of a typical house

Reference may be made in this report to some or all of the above component parts of the property. This diagram may assist you in locating and understanding these items.
