Home Report

Single Survey

Property Address	Cladach Duke Street Golspie KW10 6RP
Customer	The Executors of Mr Robert Beaton
Date of Inspection	30/03/2026
Prepared by	Jennifer Swanson Walker Fraser Steele

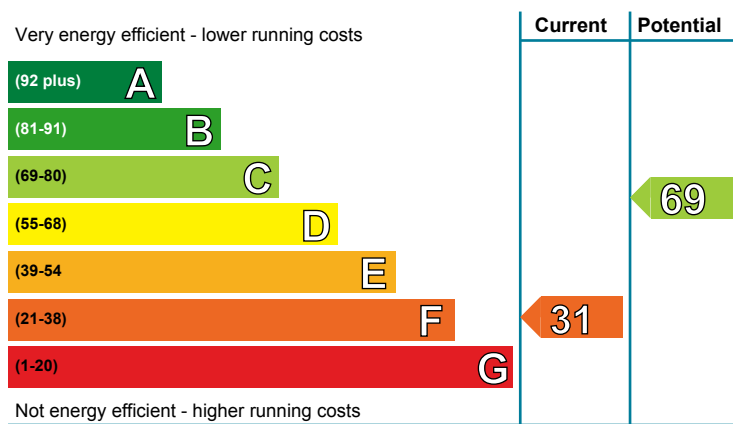
Energy Efficiency Rating

This graph shows the current efficiency of your home, taking into account both energy efficiency and fuel costs. The higher this rating, the lower your fuel bills are likely to be.

Your current rating is **band F (31)**. The average rating for EPCs in Scotland is **band D (61)**.

The potential rating shows the effect of undertaking all of the improvement measures listed within your recommendations report.

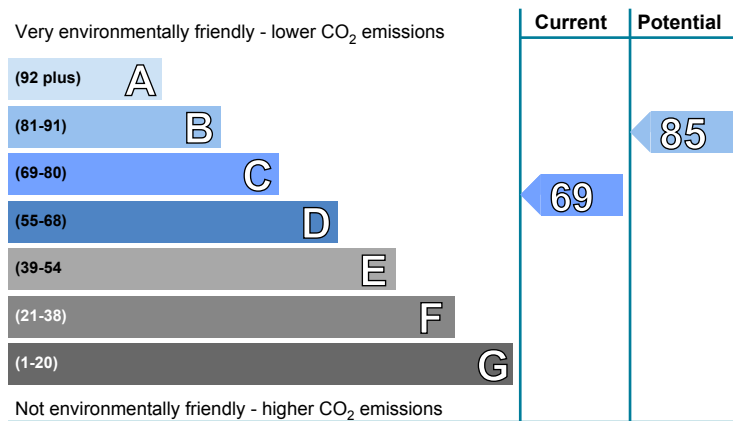
Environmental Impact (CO₂) Rating

This graph shows the effect of your home on the environment in terms of carbon dioxide (CO₂) emissions. The higher the rating, the less impact it has on the environment.
