Home Report

Single Survey

Property Address	Harbour Cottage Shore Street Helmsdale KW8 6JZ
Customer	Jamie McLean & Michaela McLean
Date of Inspection	05/05/2026
Prepared by	Jennifer Swanson Walker Fraser Steele

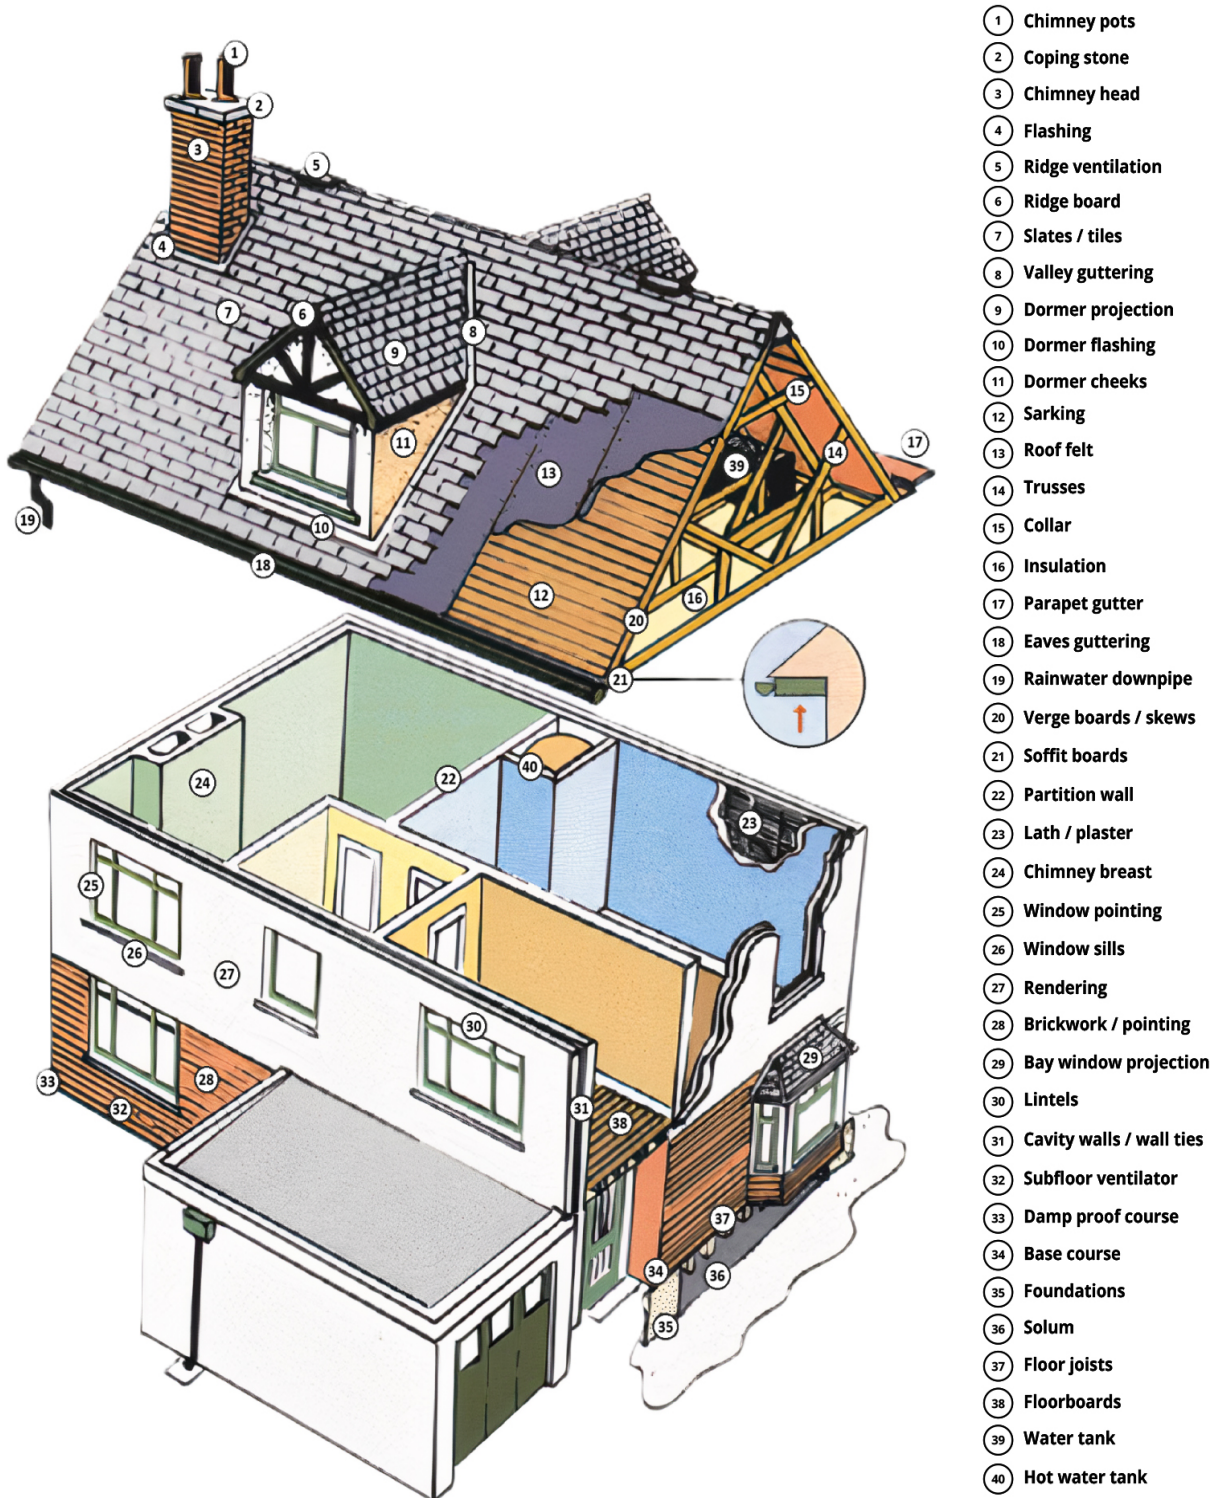
Sectional Diagram showing elements of a typical house

Reference may be made in this report to some or all of the above component parts of the property. This diagram may assist you in locating and understanding these items.

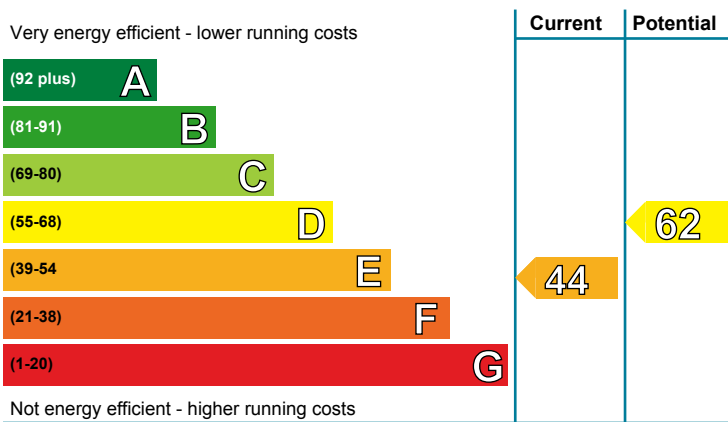
Energy Efficiency Rating

This graph shows the current efficiency of your home, taking into account both energy efficiency and fuel costs. The higher this rating, the lower your fuel bills are likely to be.

Your current rating is **band E (44)**. The average rating for EPCs in Scotland is **band D (61)**.

The potential rating shows the effect of undertaking all of the improvement measures listed within your recommendations report.

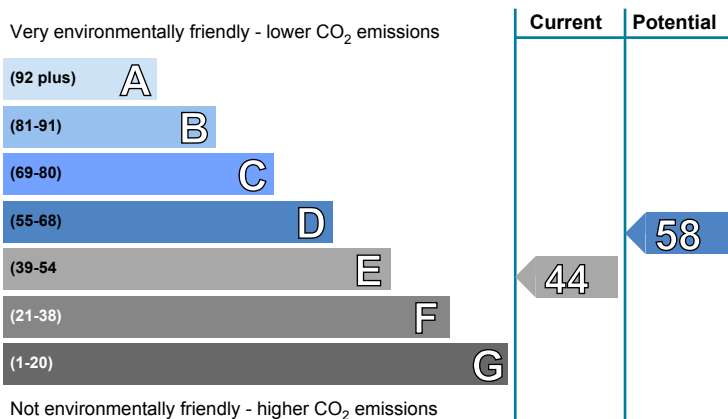
Environmental Impact (CO₂) Rating

This graph shows the effect of your home on the environment in terms of carbon dioxide (CO₂) emissions. The higher the rating, the less impact it has on the environment.
